Challenge Accepted: Uneven Floors, Swinging Obstacles are no Problem for Work Station Crane

Two Gorbels Work Station Cranes with combination of Free Standing supports and Ceiling supports

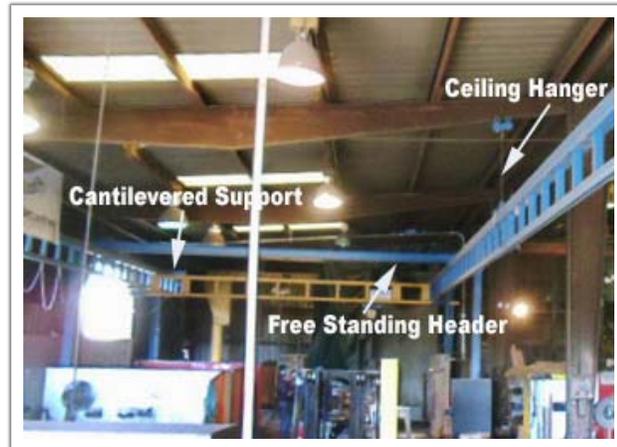
The customer purchased a 2 ton capacity Gorbels work station crane with custom supports to serve the entire work area. By using a combination of support structures, the crane provides complete coverage to the entire facility.

The crane has support at four points, each with a different configuration. On the low end of the sloping floor, the runways are supported with ceiling mounted hangers. The second support point is suspended from the ceiling on one side, which is a high traffic area for fork lifts, and a cantilevered support at the other end, where ceiling obstructions are the problem. The third support could not mount to the ceiling due to overhead obstacles, so it features a standard freestanding header. Finally, and at the end of the

system that faces an adjacent work bay that needed to remain accessible, cantilevered supports hold both the runways, and allow a nearby jib crane to move products into the work area.
